# METRO THERMAL ASH MONOFILL CLOSURE CAP

## STORMWATER DAMAGE AND RESTORATION UPDATE

# METRO THERMAL ASH MONOFILL

## Metro Nashville Public Works

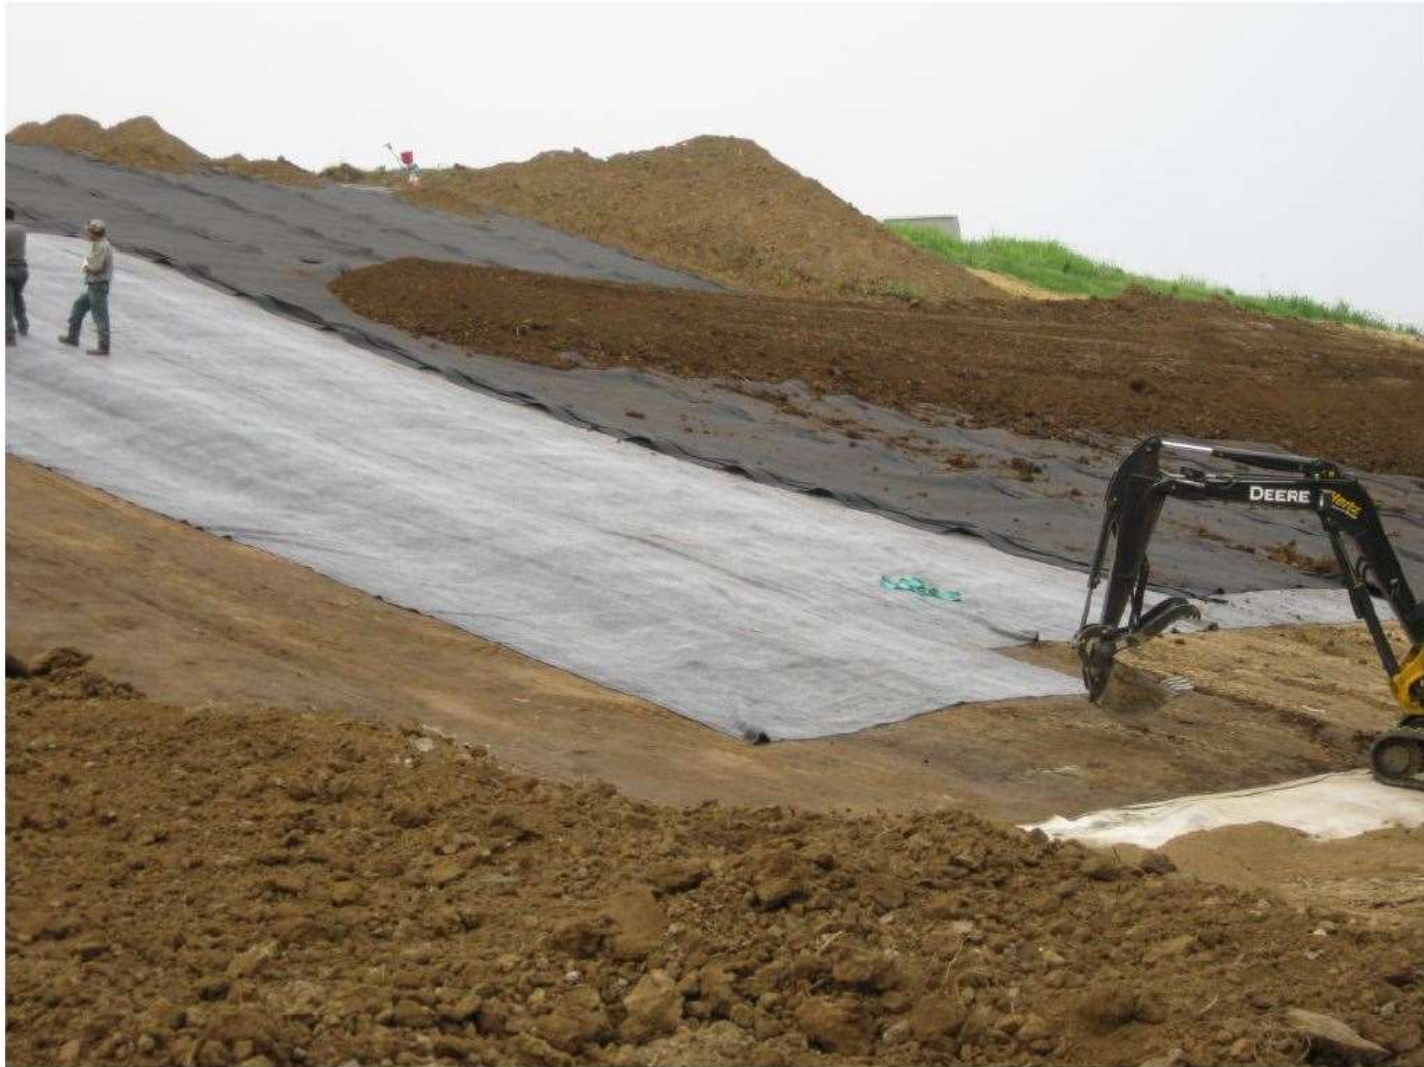
**Subarea-C, deploy GCL panels**

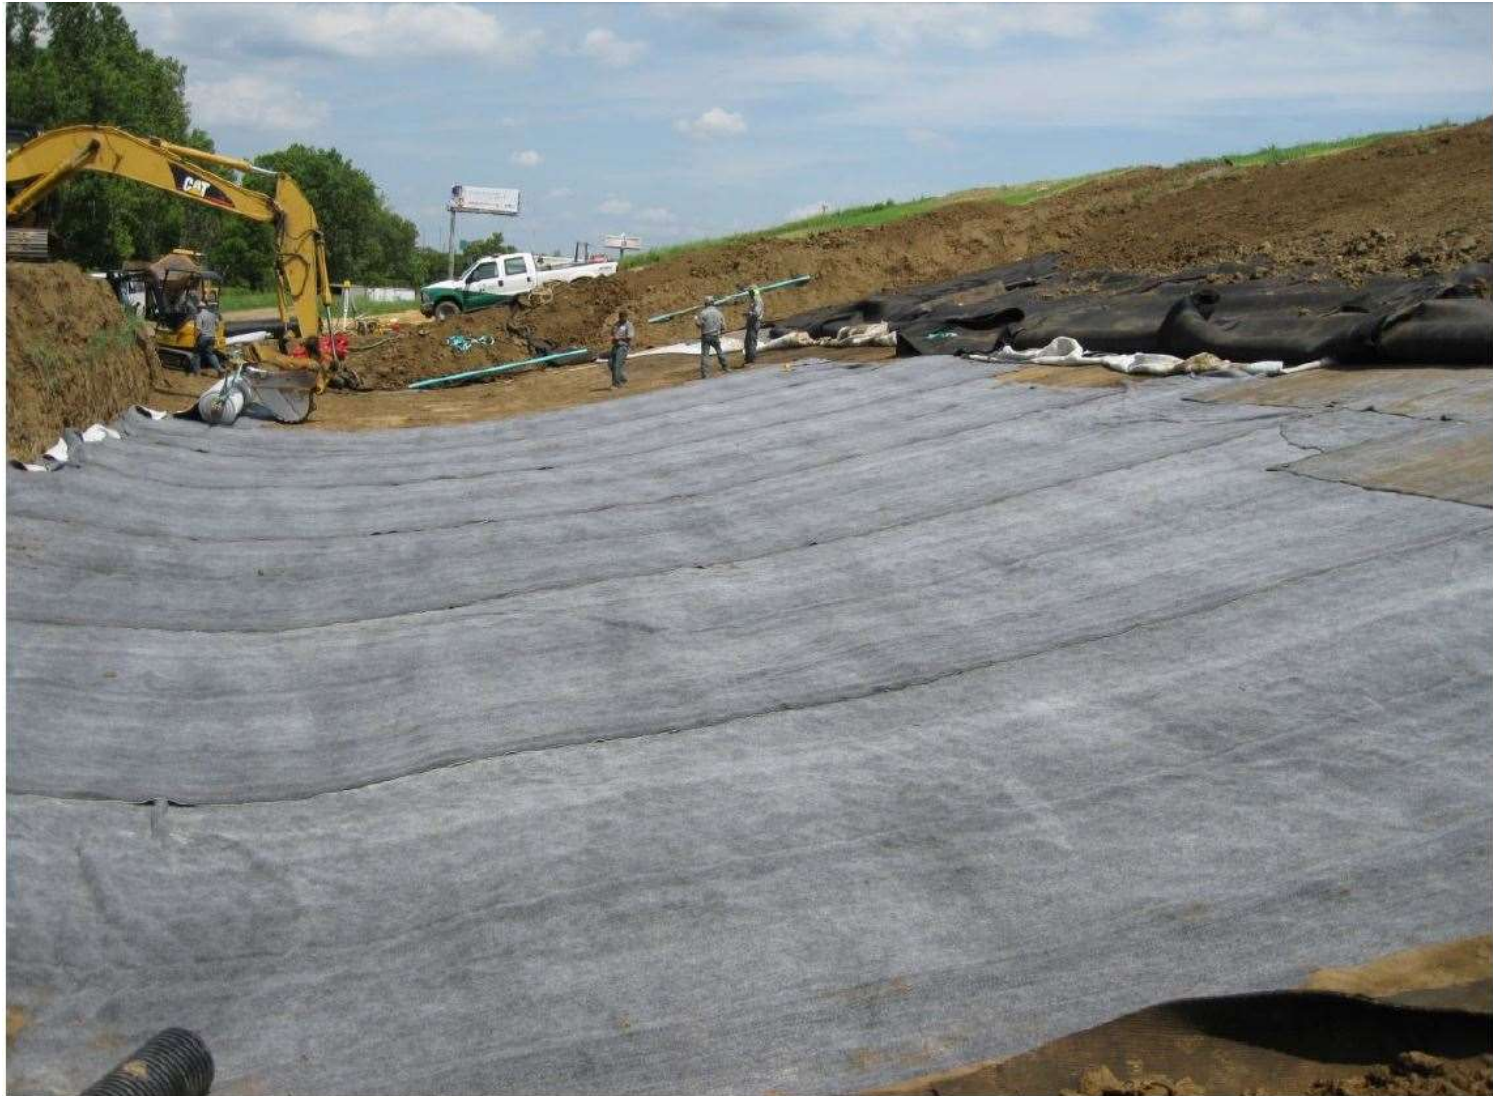
Subarea-C, GCL deployment

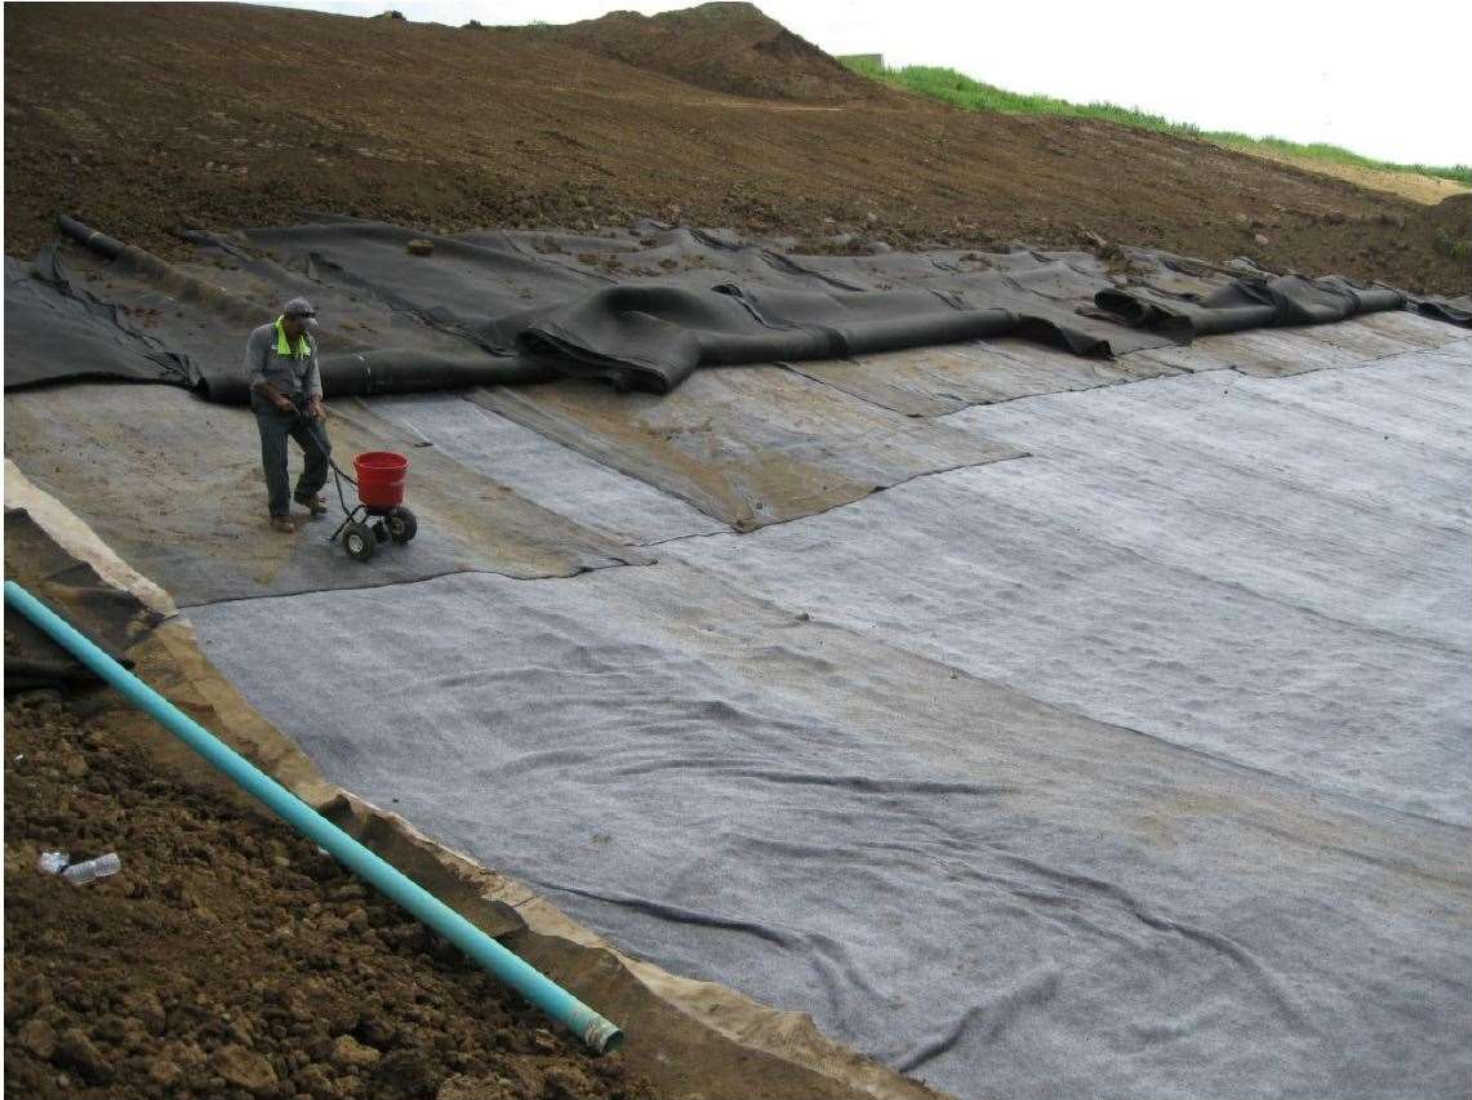
Subarea-C, sand placement over GCL

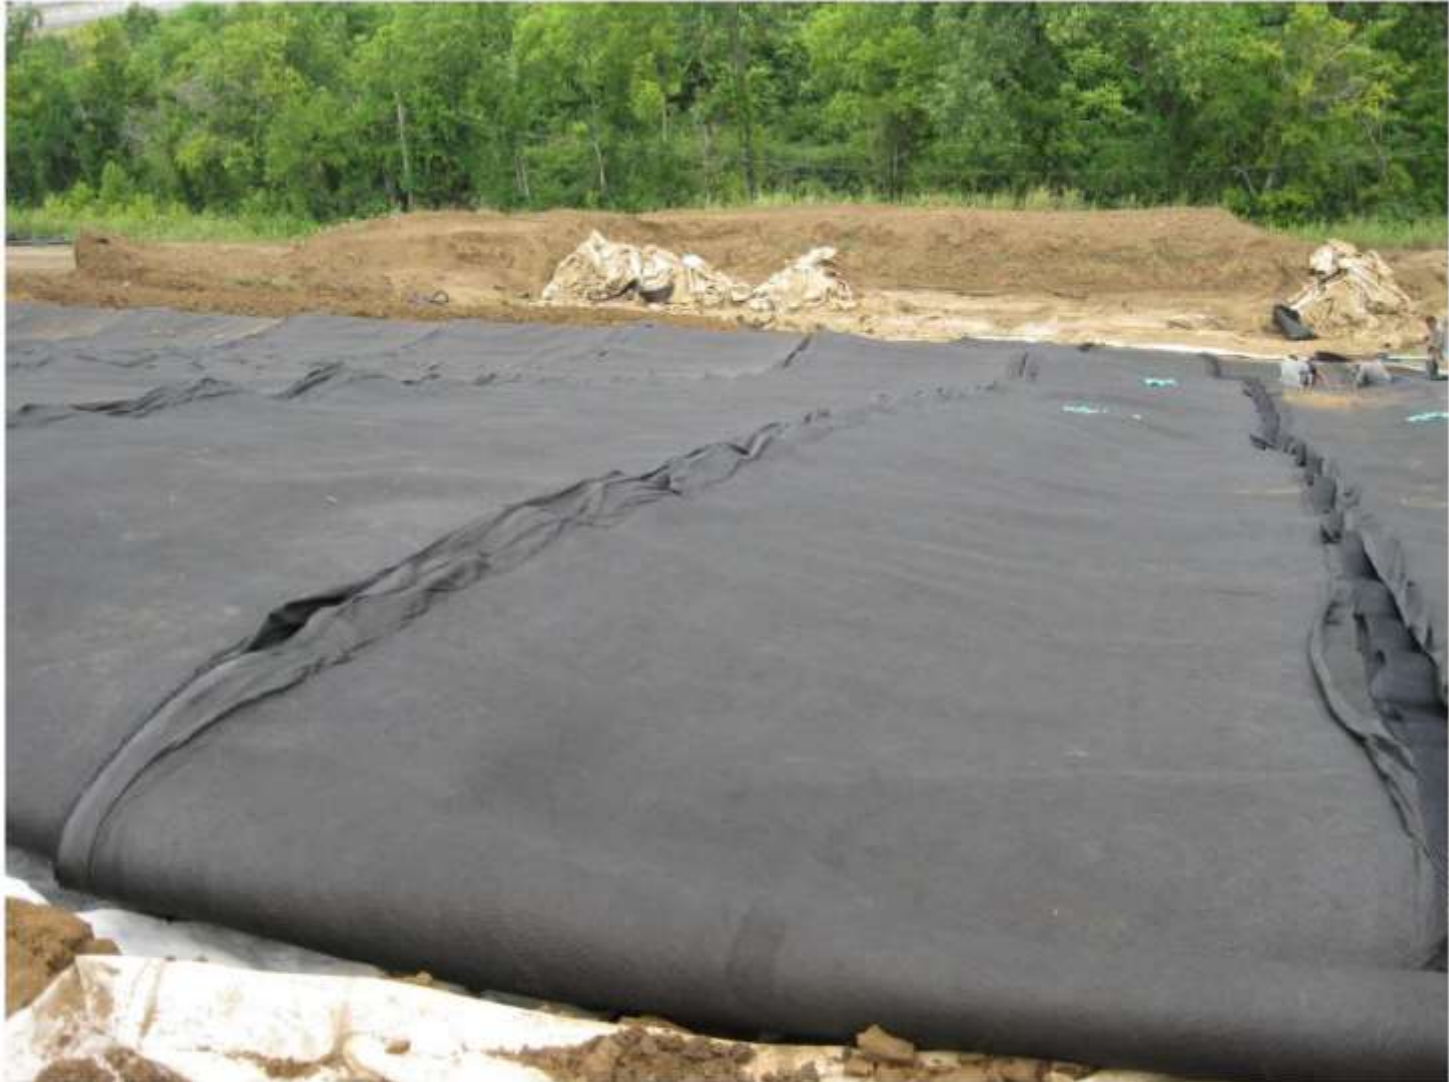
**Subarea-C, drainage composite in anchor trench**

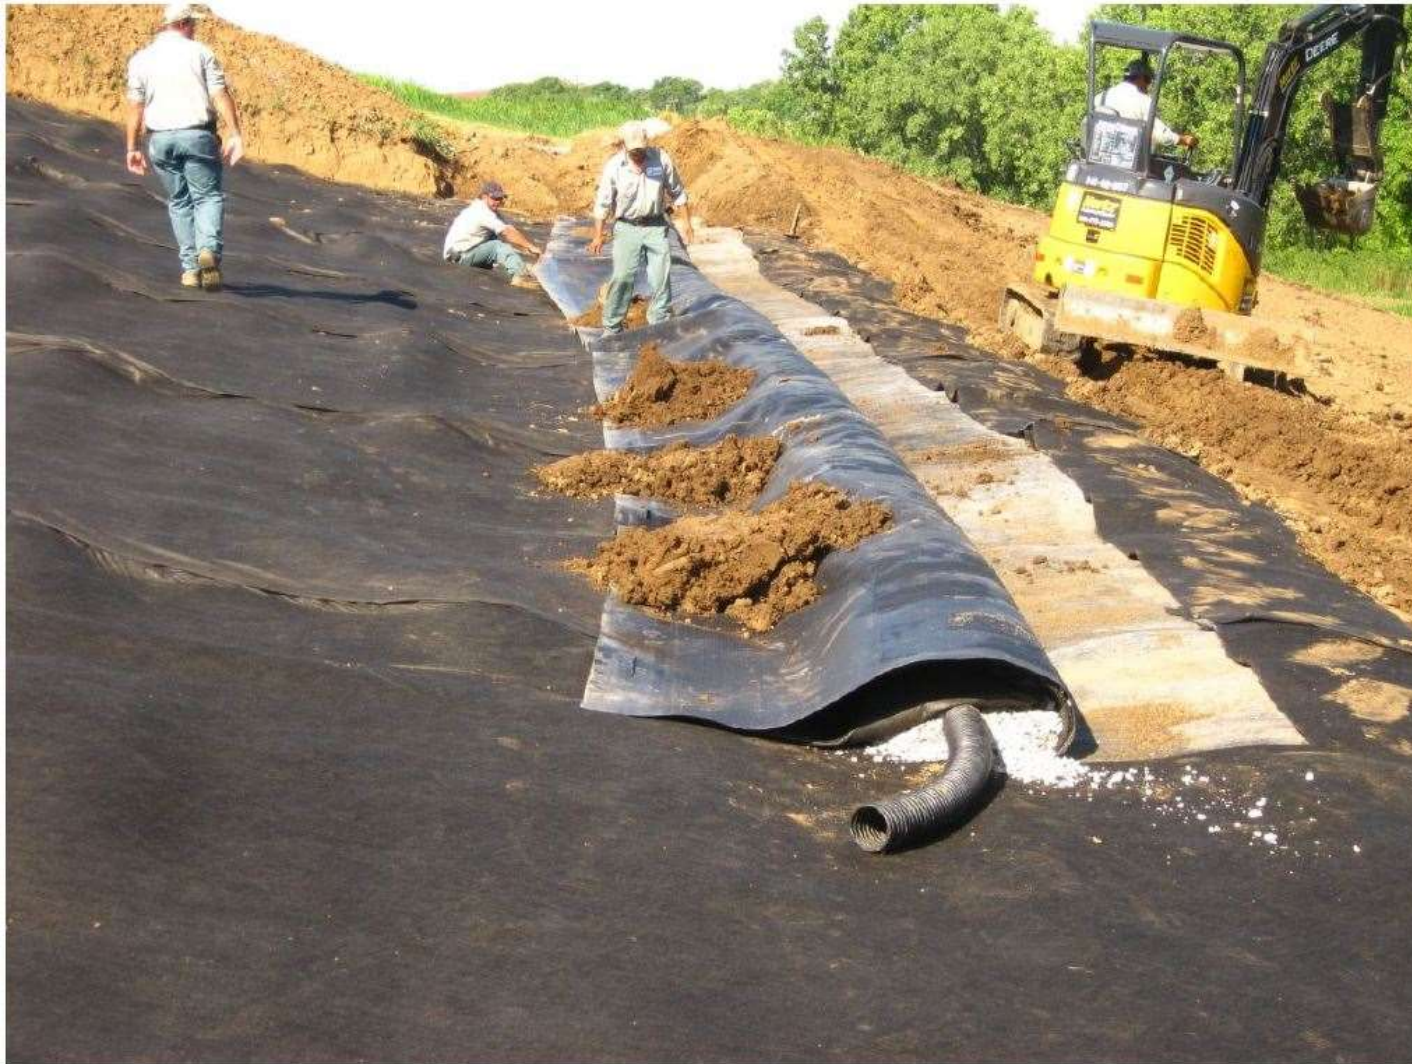
**Subarea-C, bench restoration**

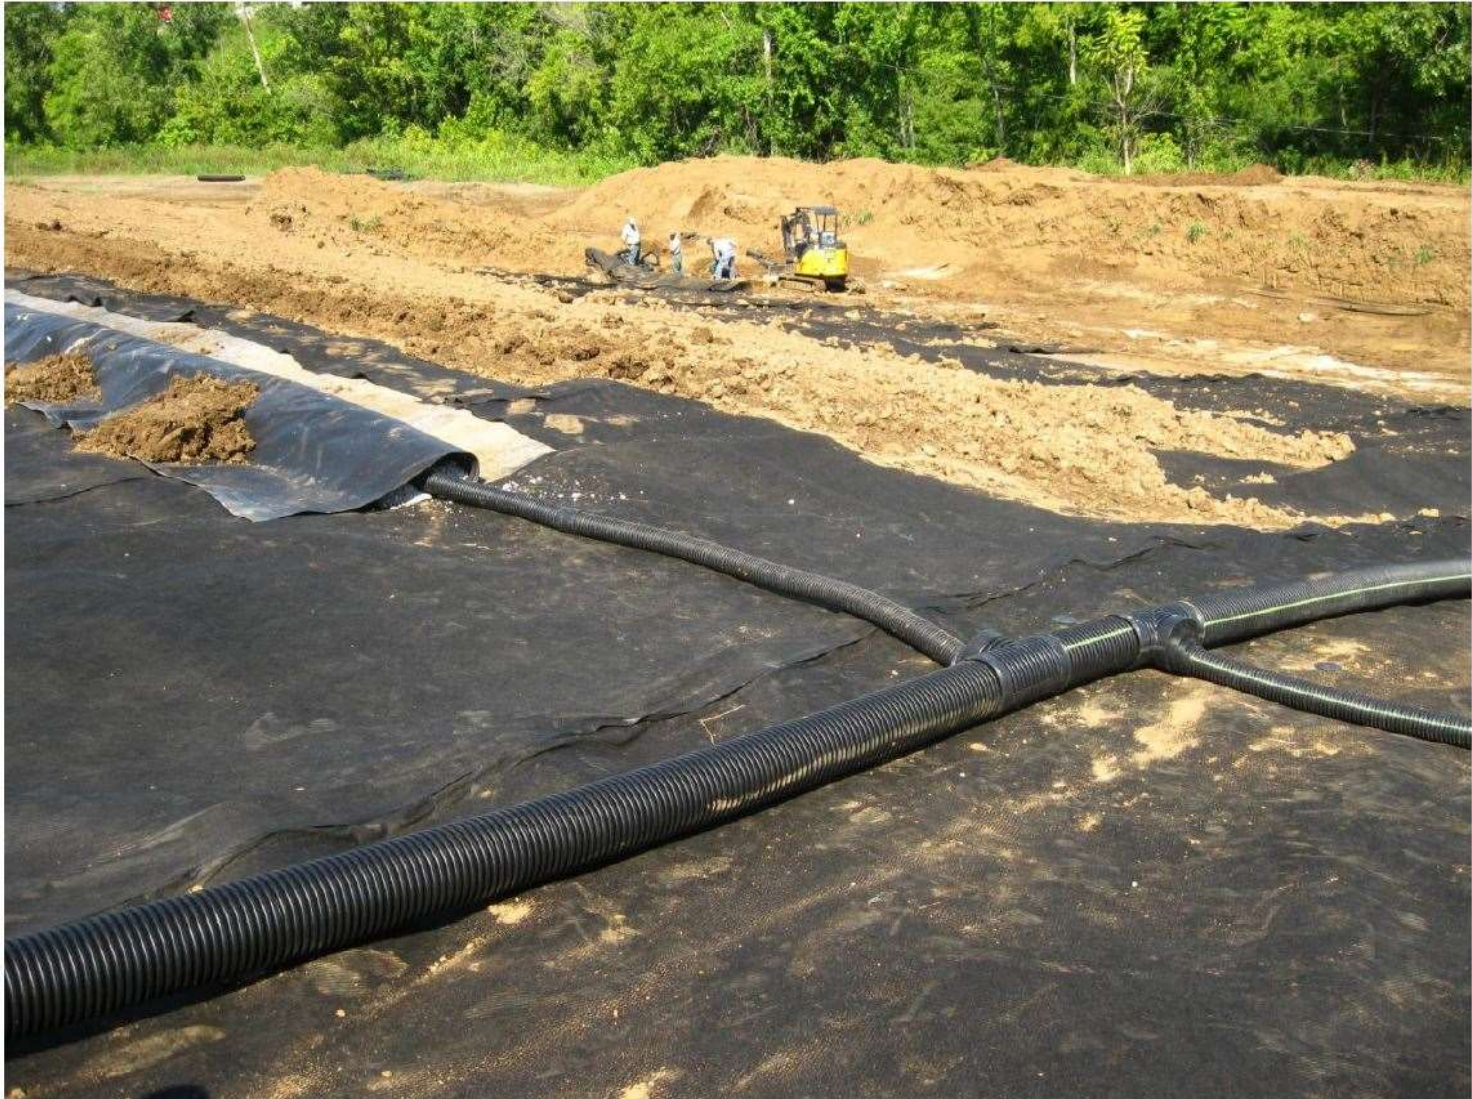
Subarea-C, letdown underdrain

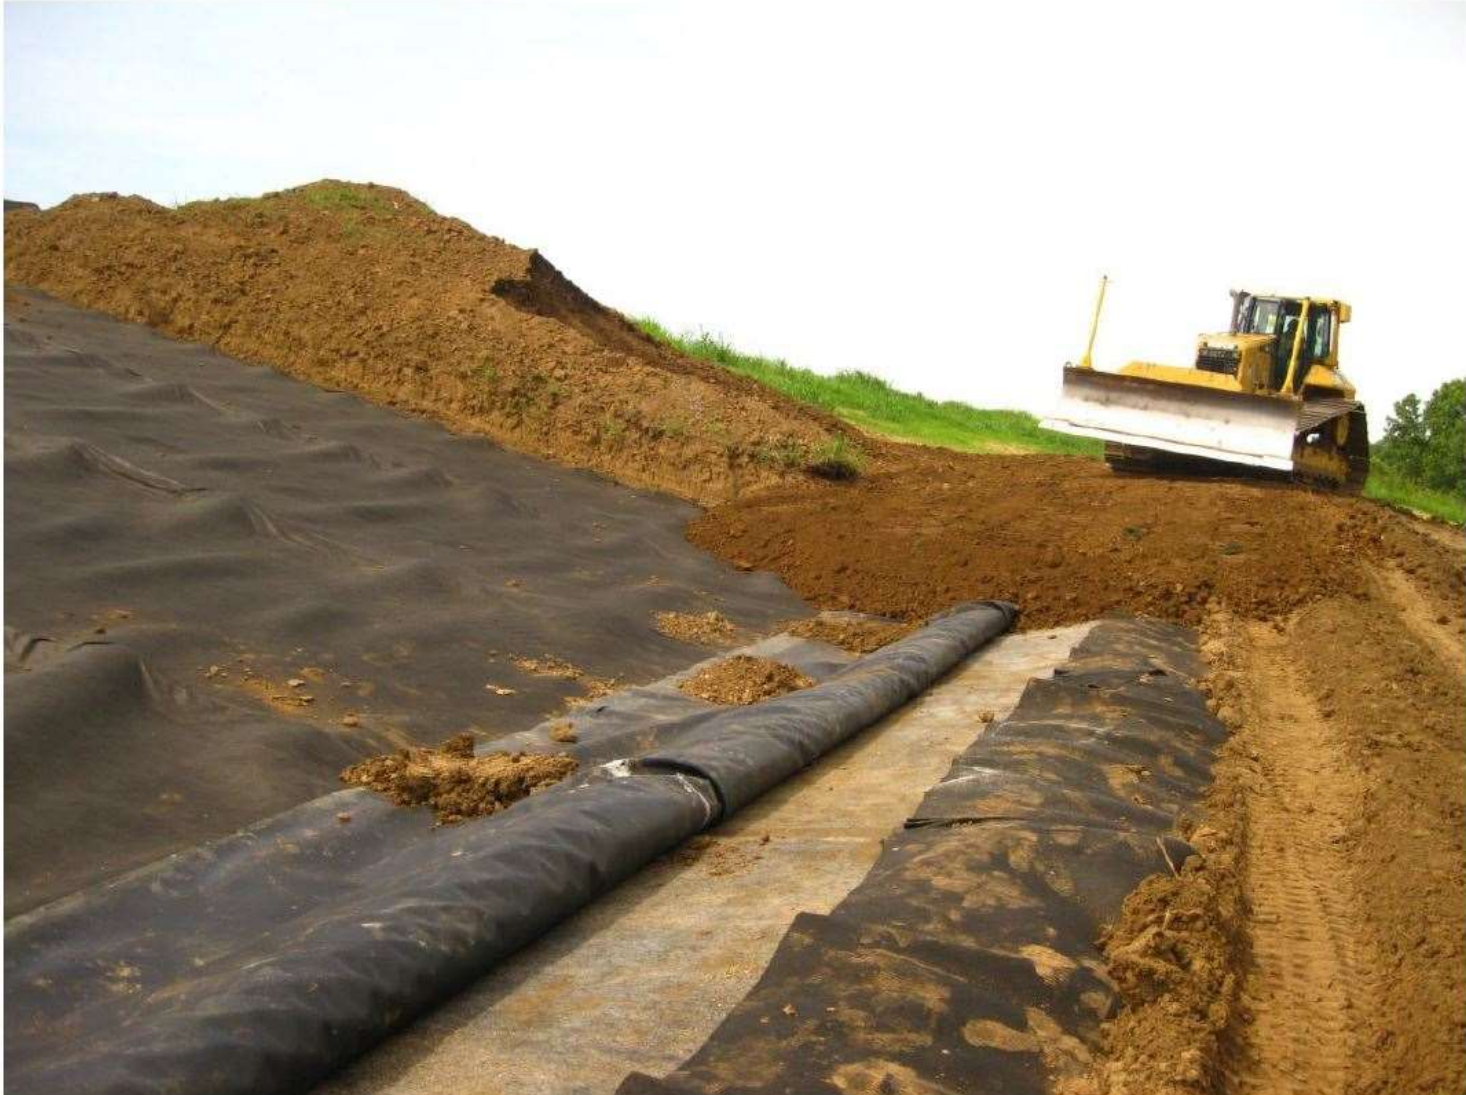
**Subarea-C, soil cover placement**

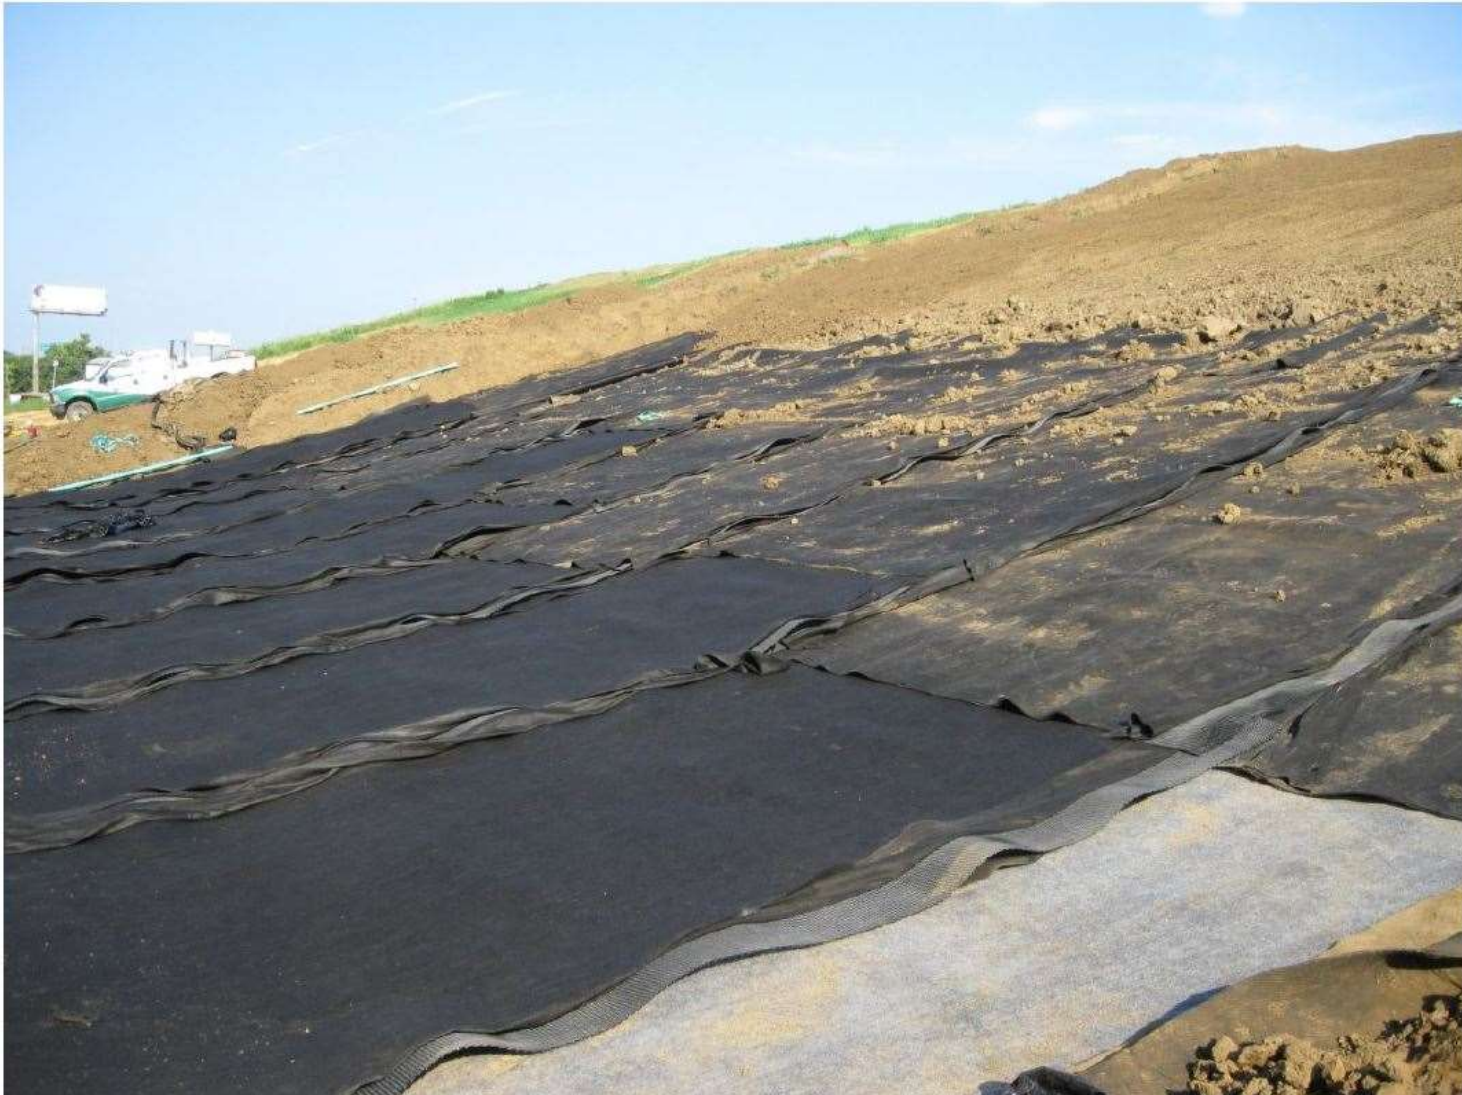
Subarea-C, drainage composite deployment

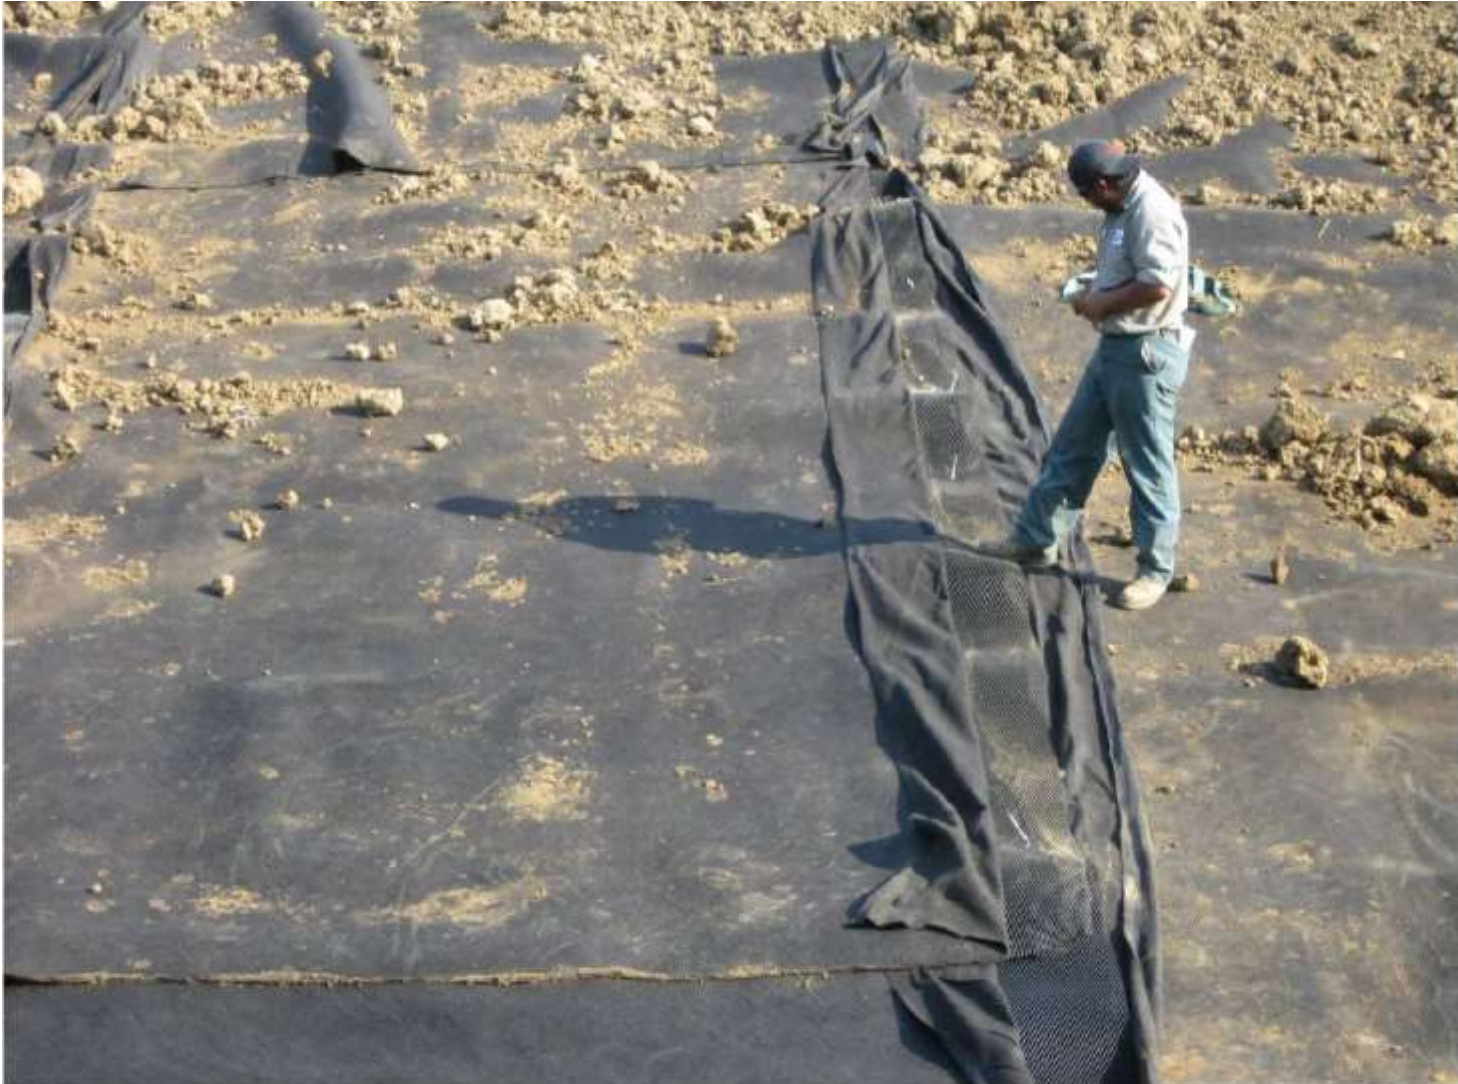
Subarea-C, zip tie drainage composite

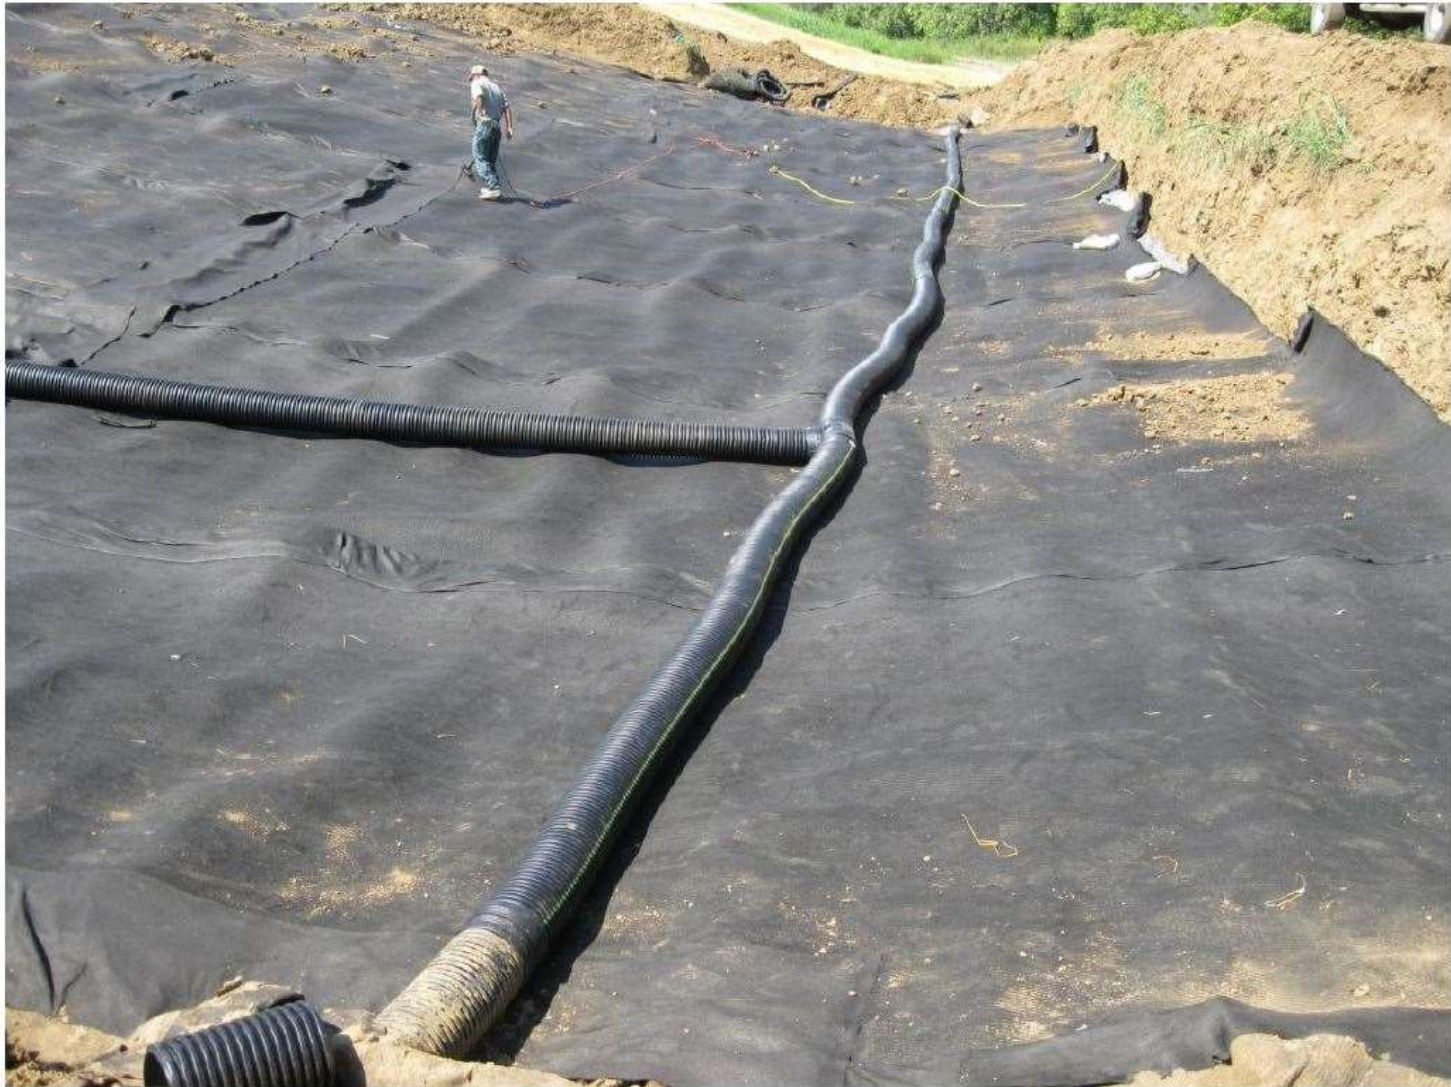
**Subarea-C, toe drain construction**

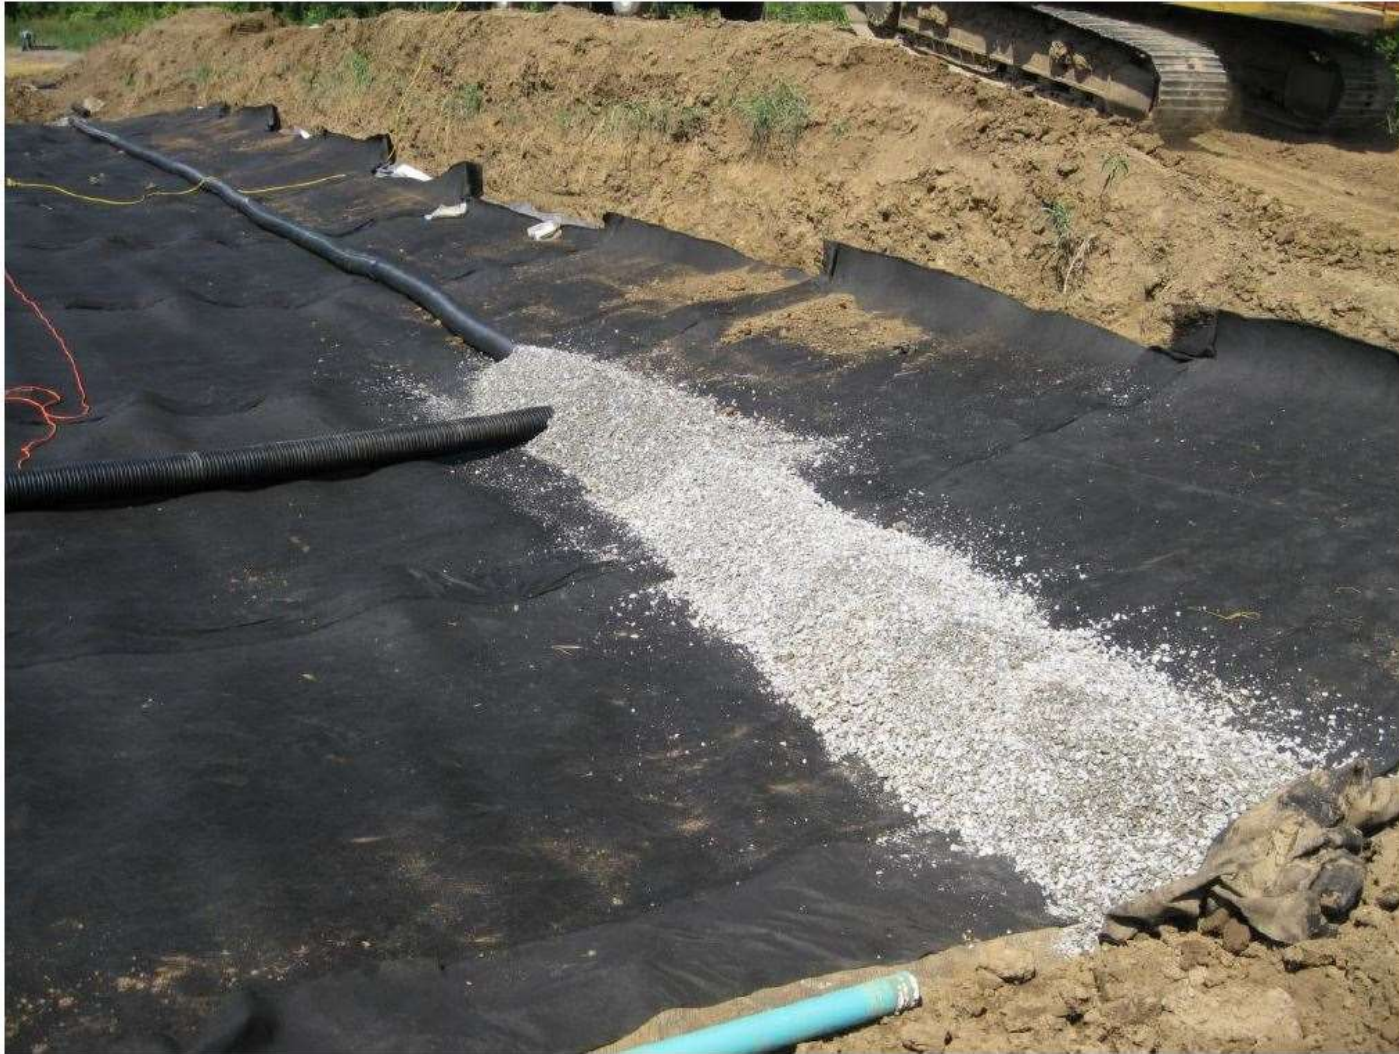
**Subarea-C, toe drain construction**

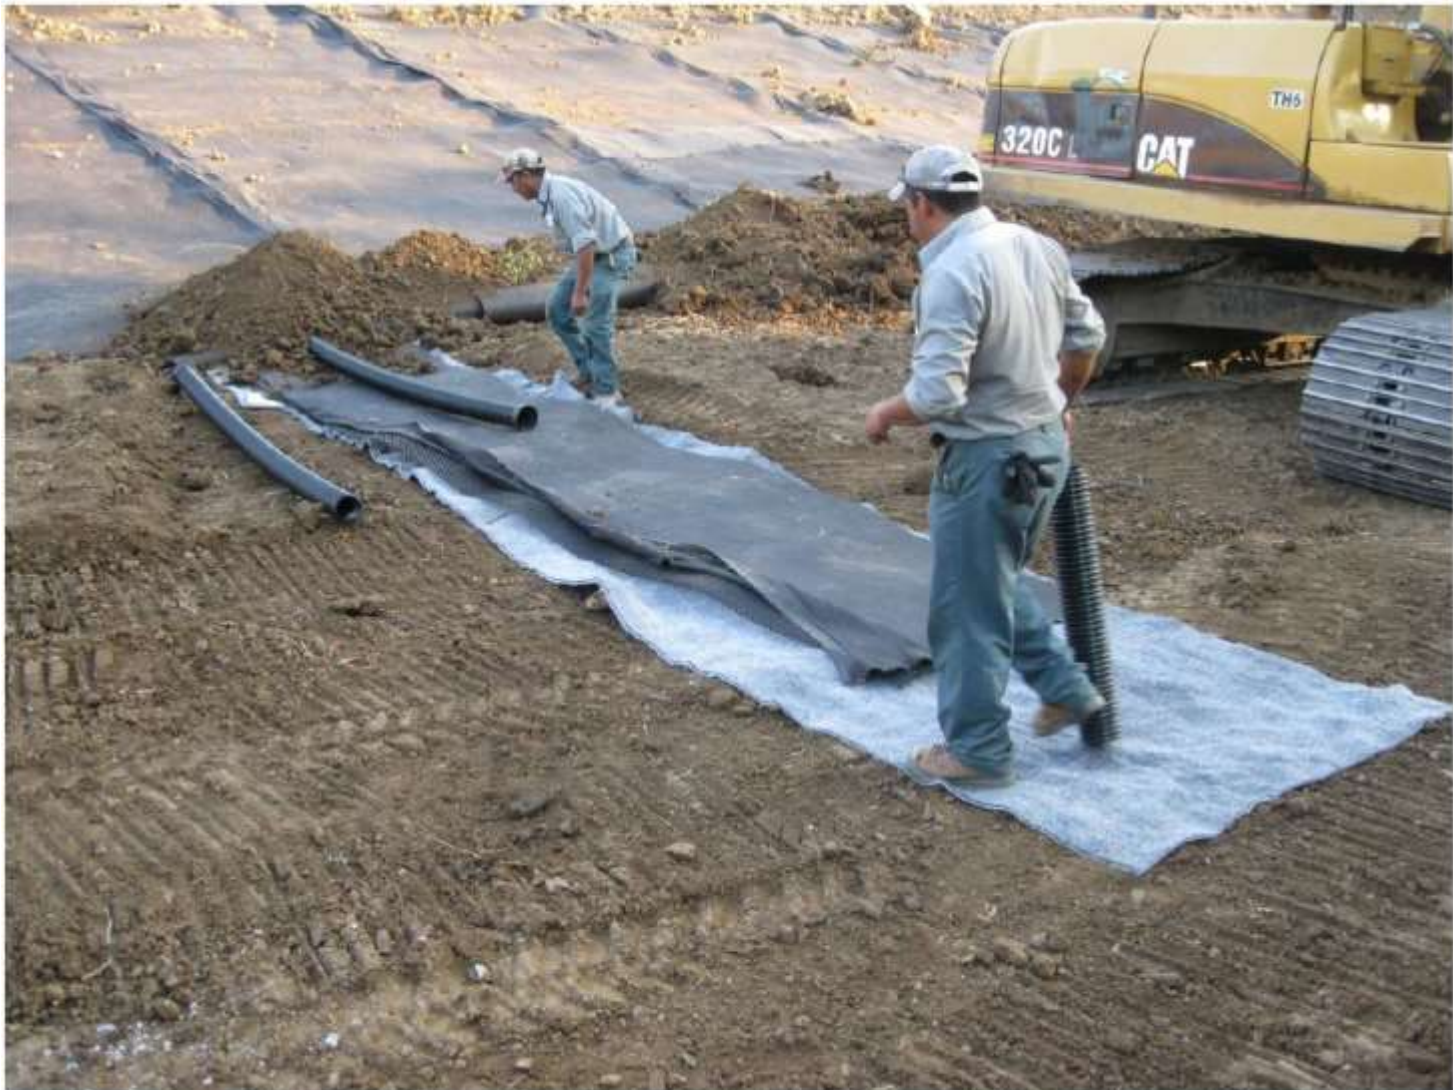
**Subarea-C, cap drain modification construction**

- ❖ Regrade T-cracked slope areas and revegetate
- ❖ Provide a “break” in the bench drainage geocomposite (inspect underdrains)
- ❖ “Daylight” the drainage geocomposite into the perimeter channel through cap drain modification - disconnect from P. Underdrain
- ❖ Clean/reshape perimeter channel

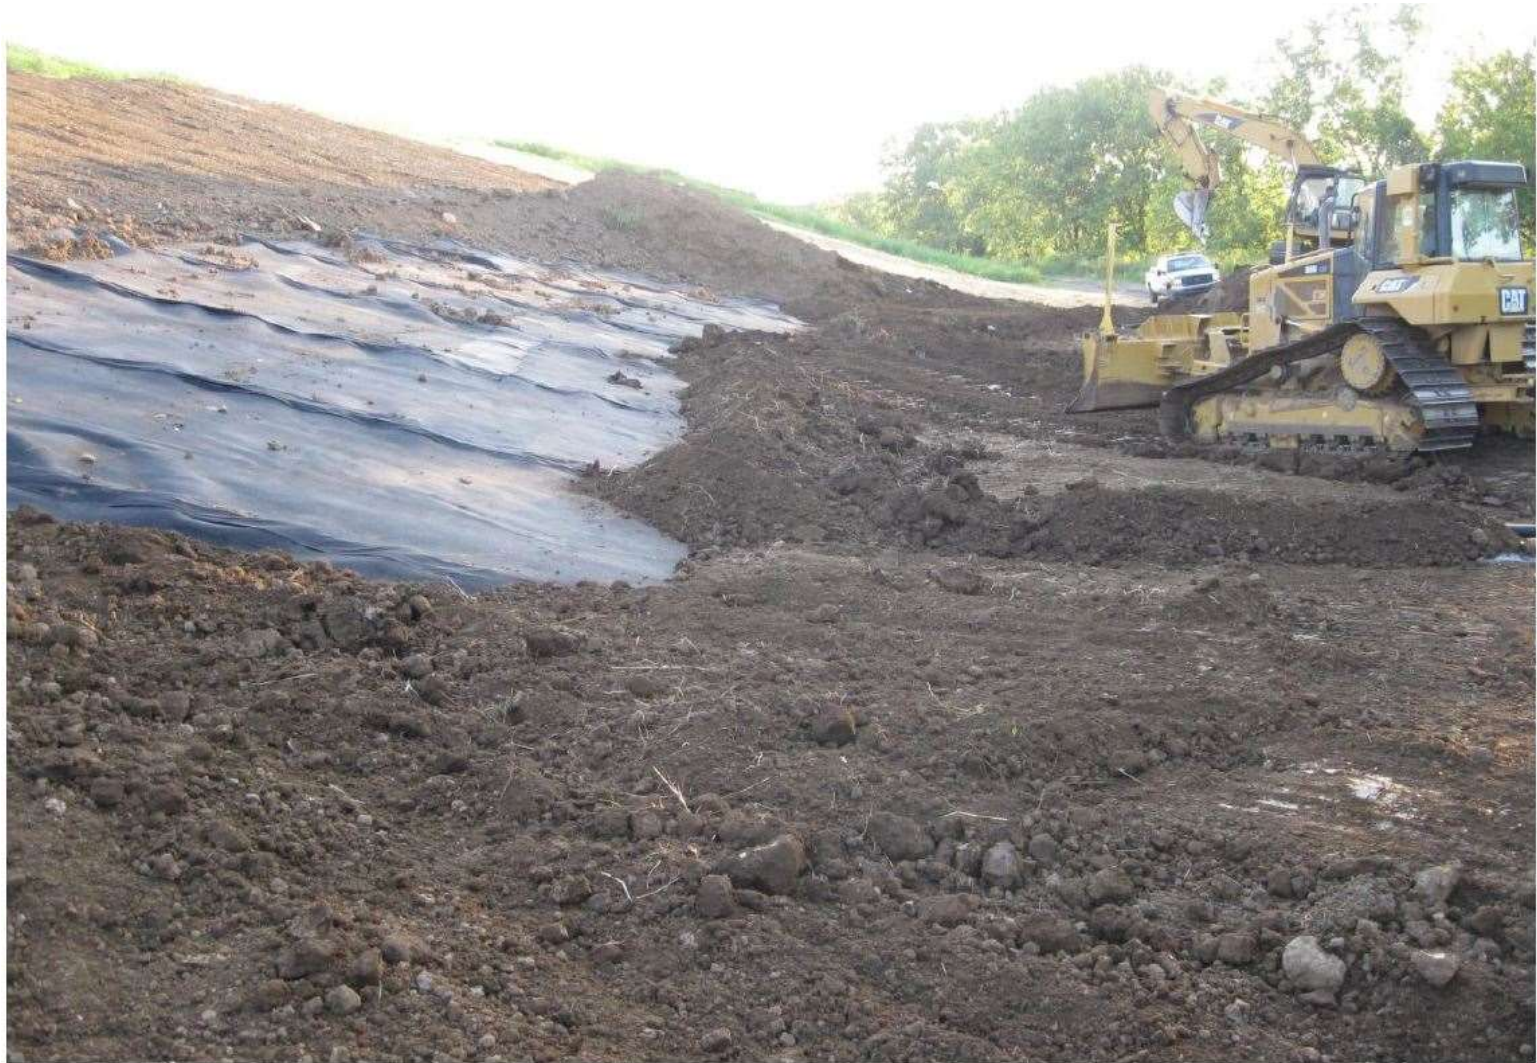
**Subarea-C, soil cover placement over cap drain modification**

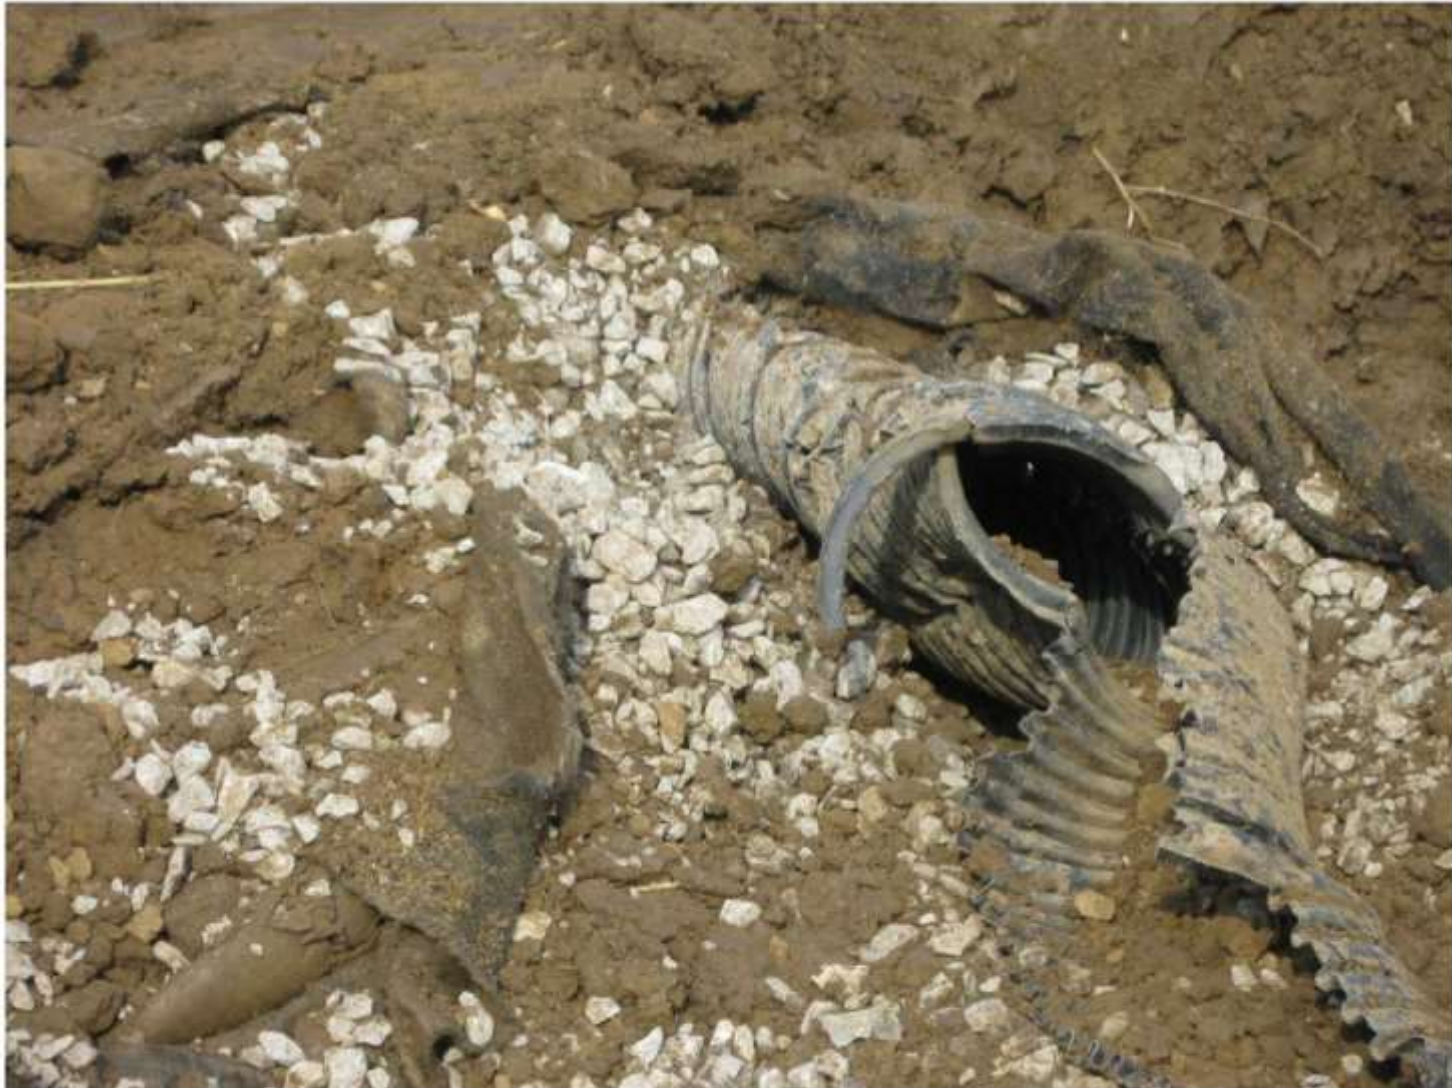
Subarea-C, underdrain coming from Subarea-D
